Applied Geotechnical Engineering Consultants, Inc.

August 4, 1998

Subject: Supplemental Geotechnical Investigation  
Green Hill Country Estates Phase VI  
Part of Sections 4 and 9, T6N, R2E, SLB&M  
Weber County, Utah  
Project No. 66095

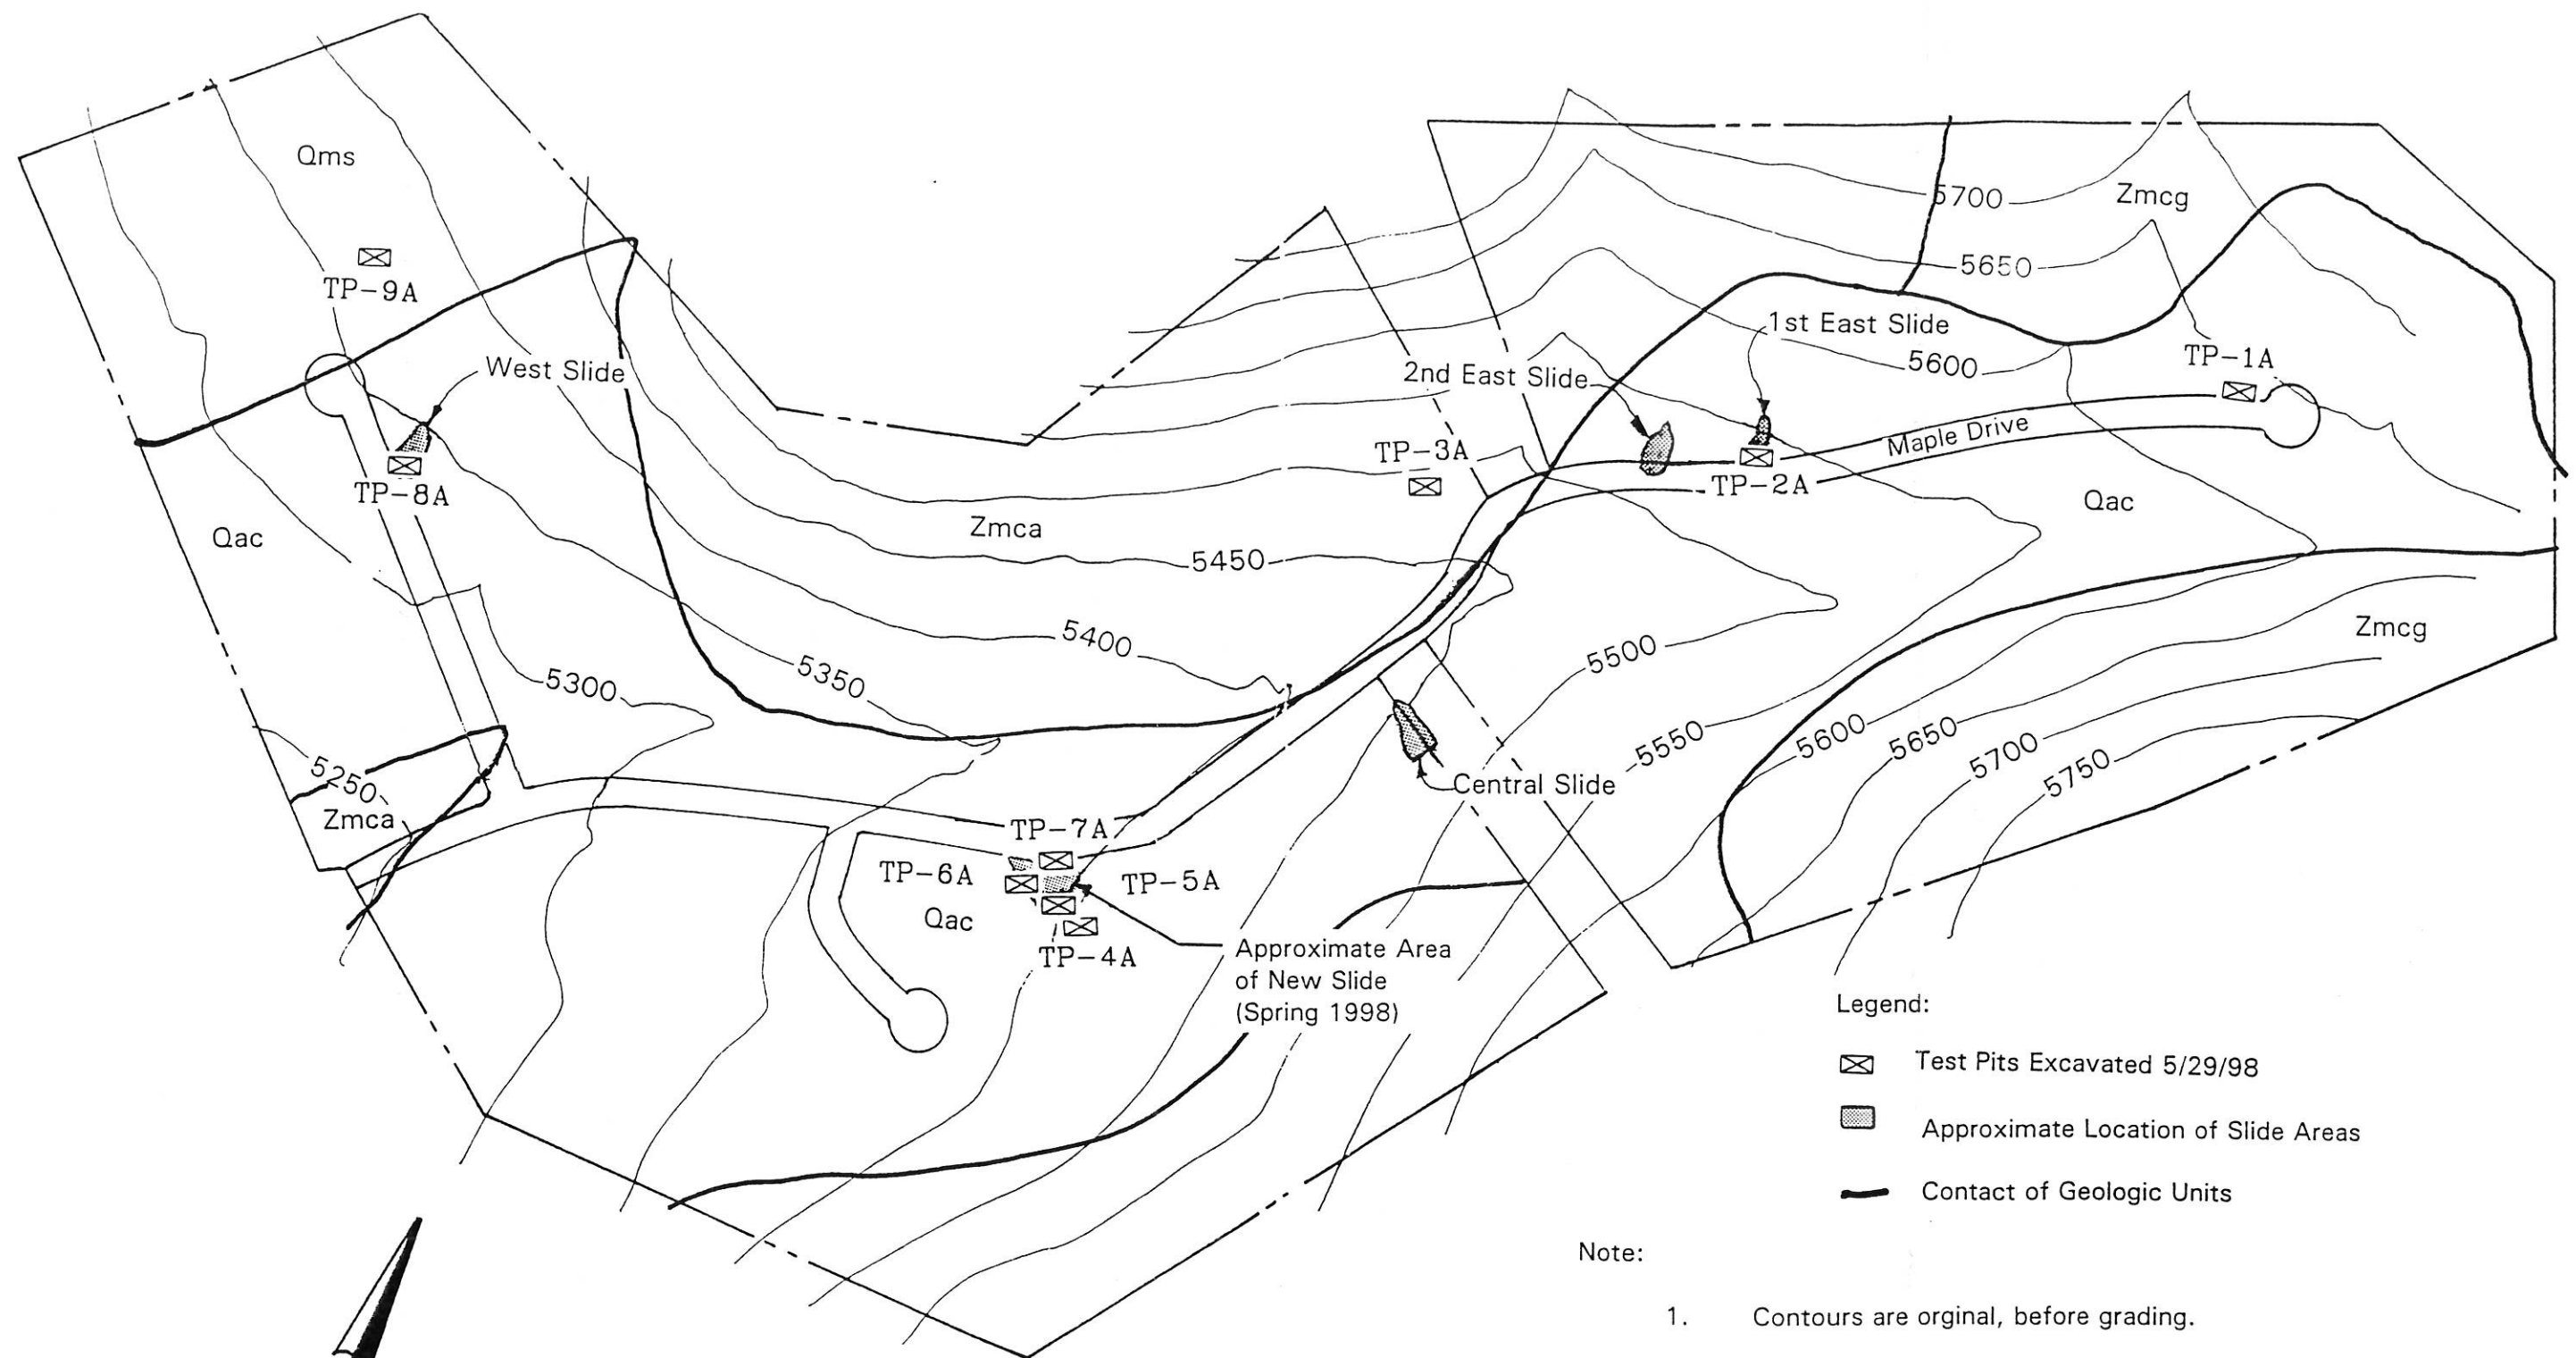
One additional slide area was observed at the approximate location shown on Figure 2. The slide appears to be a relatively shallow failure and appears to have occurred as a result of the existing road cut. The soil in the new slide area is very moist to wet and relatively soft, similar to previous slide areas studied. There is a natural spring up-slope from the new slide area.

The approximate locations of the previously studied slide areas are also shown on Figure 2. These areas were observed at the time of our site visits. The slide areas were measured to extend further up the slope and wider than they were at the time of our previous study.

Based on our discussion with the developer, we understand that soil was removed from the slide areas following our previous study and prior to the time of our subsequent site visits. It appears that the removal of soil from the slide areas has allowed the slope above the previous slide area to move as a result of removal of the resisting soil mass.

1. Existing slide areas, including the new slide area, should be repaired to protect road cuts and the stability of the adjacent hillside. Recommendations for repairing the slide areas are presented in the above referenced report.
2. Site grading should be carefully planned for the proposed residences. Lot specific geotechnical investigations should be conducted to evaluate stability of proposed and existing cuts, fills and retaining systems.
3. Recommendations given in the above referenced geotechnical report should be followed.

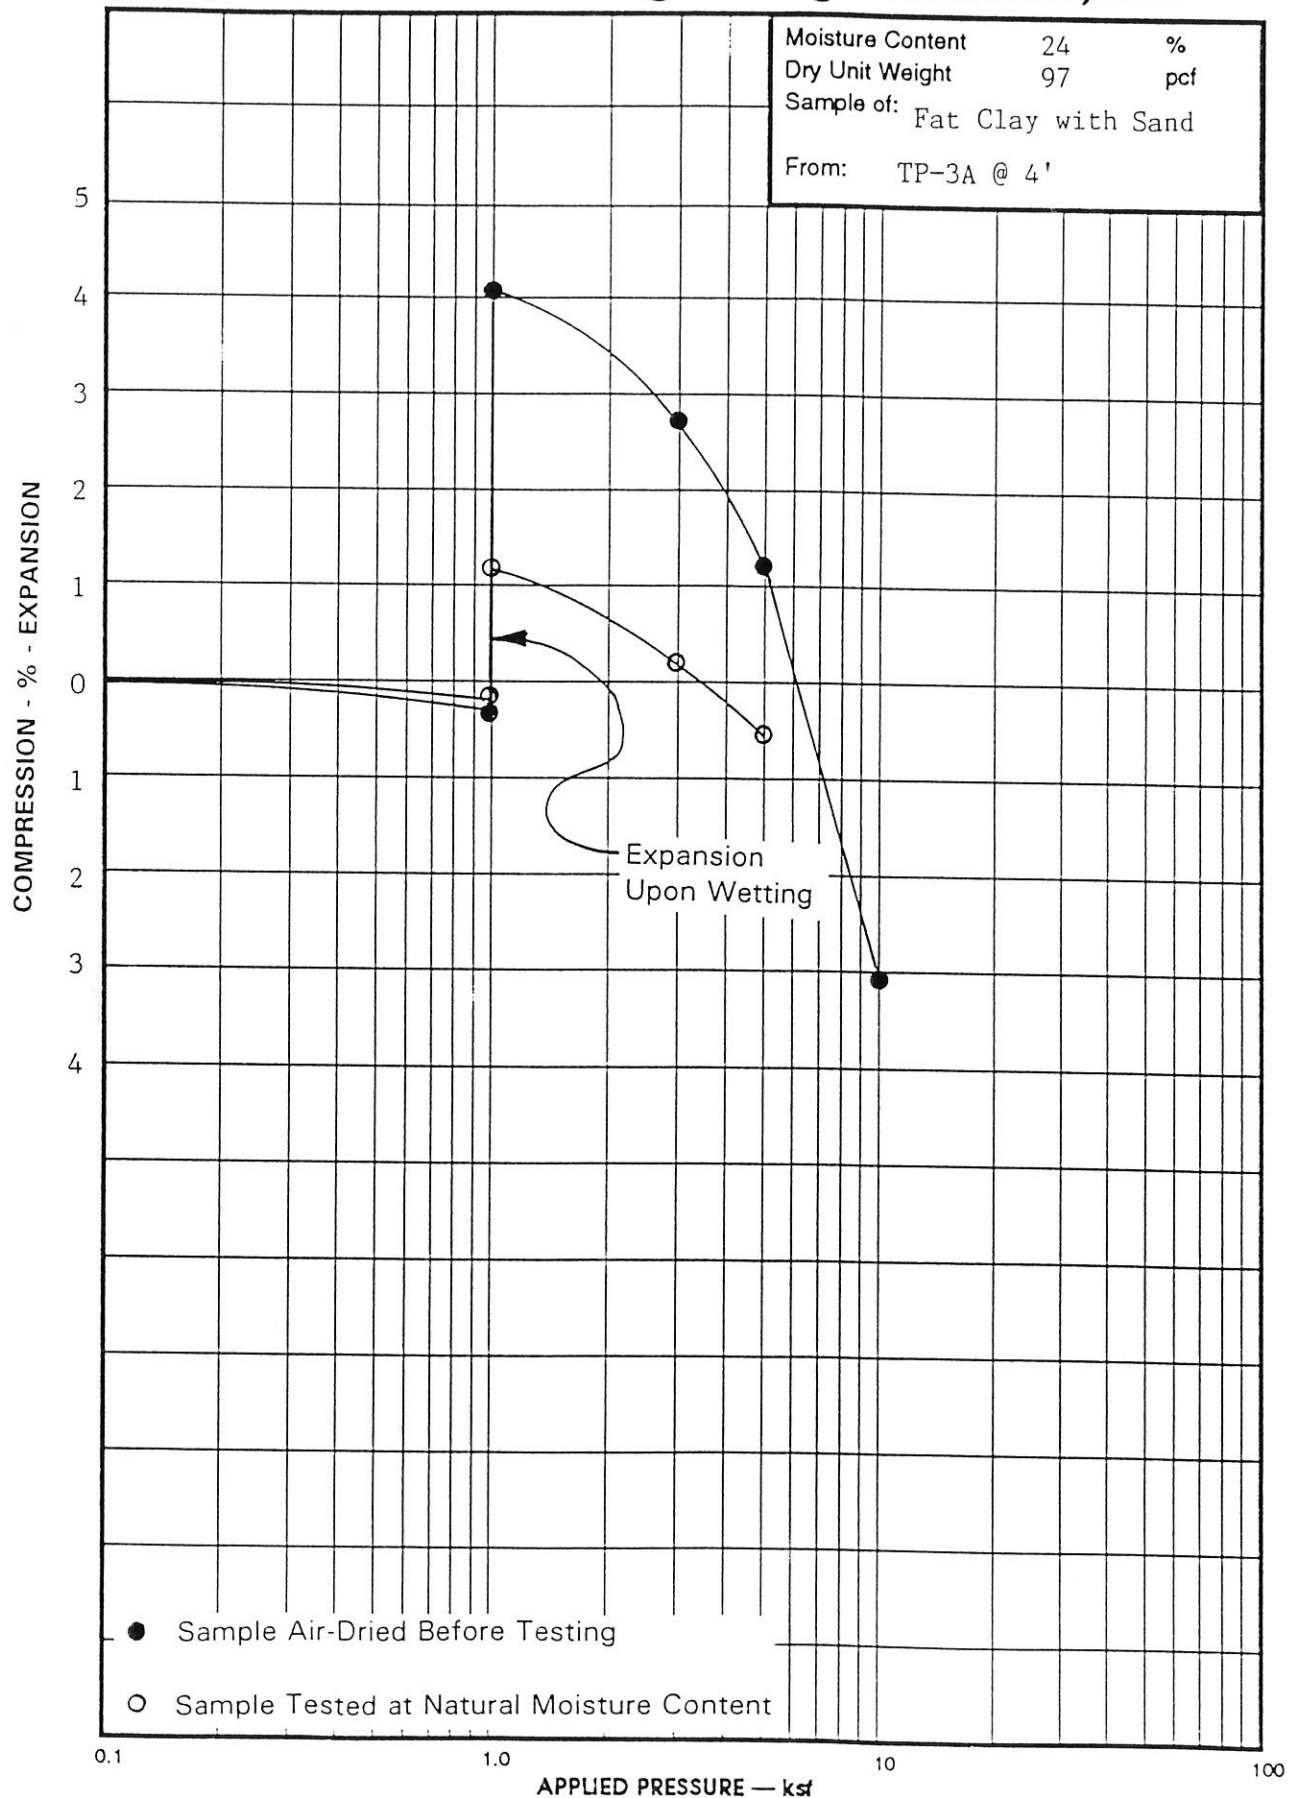
Figure 5

Consolidation tests conducted on samples of the clay (conducted on samples with their in-situ moisture content) indicate that the clay will swell slightly and compress a small amount with the addition of light to moderate loads. When the samples were air-dried

prior to testing, the soil was observed to be moderately to highly expansive when wetted. Results of the consolidation tests are presented on Figures 5, 6 and 7.
