Applied Geotechnical Engineering Consultants, Inc.

August 4, 1998

Subject: Supplemental Geotechnical Investigation  
Green Hill Country Estates Phase VI  
Part of Sections 4 and 9, T6N, R2E, SLB&M  
Weber County, Utah  
Project No. 66095

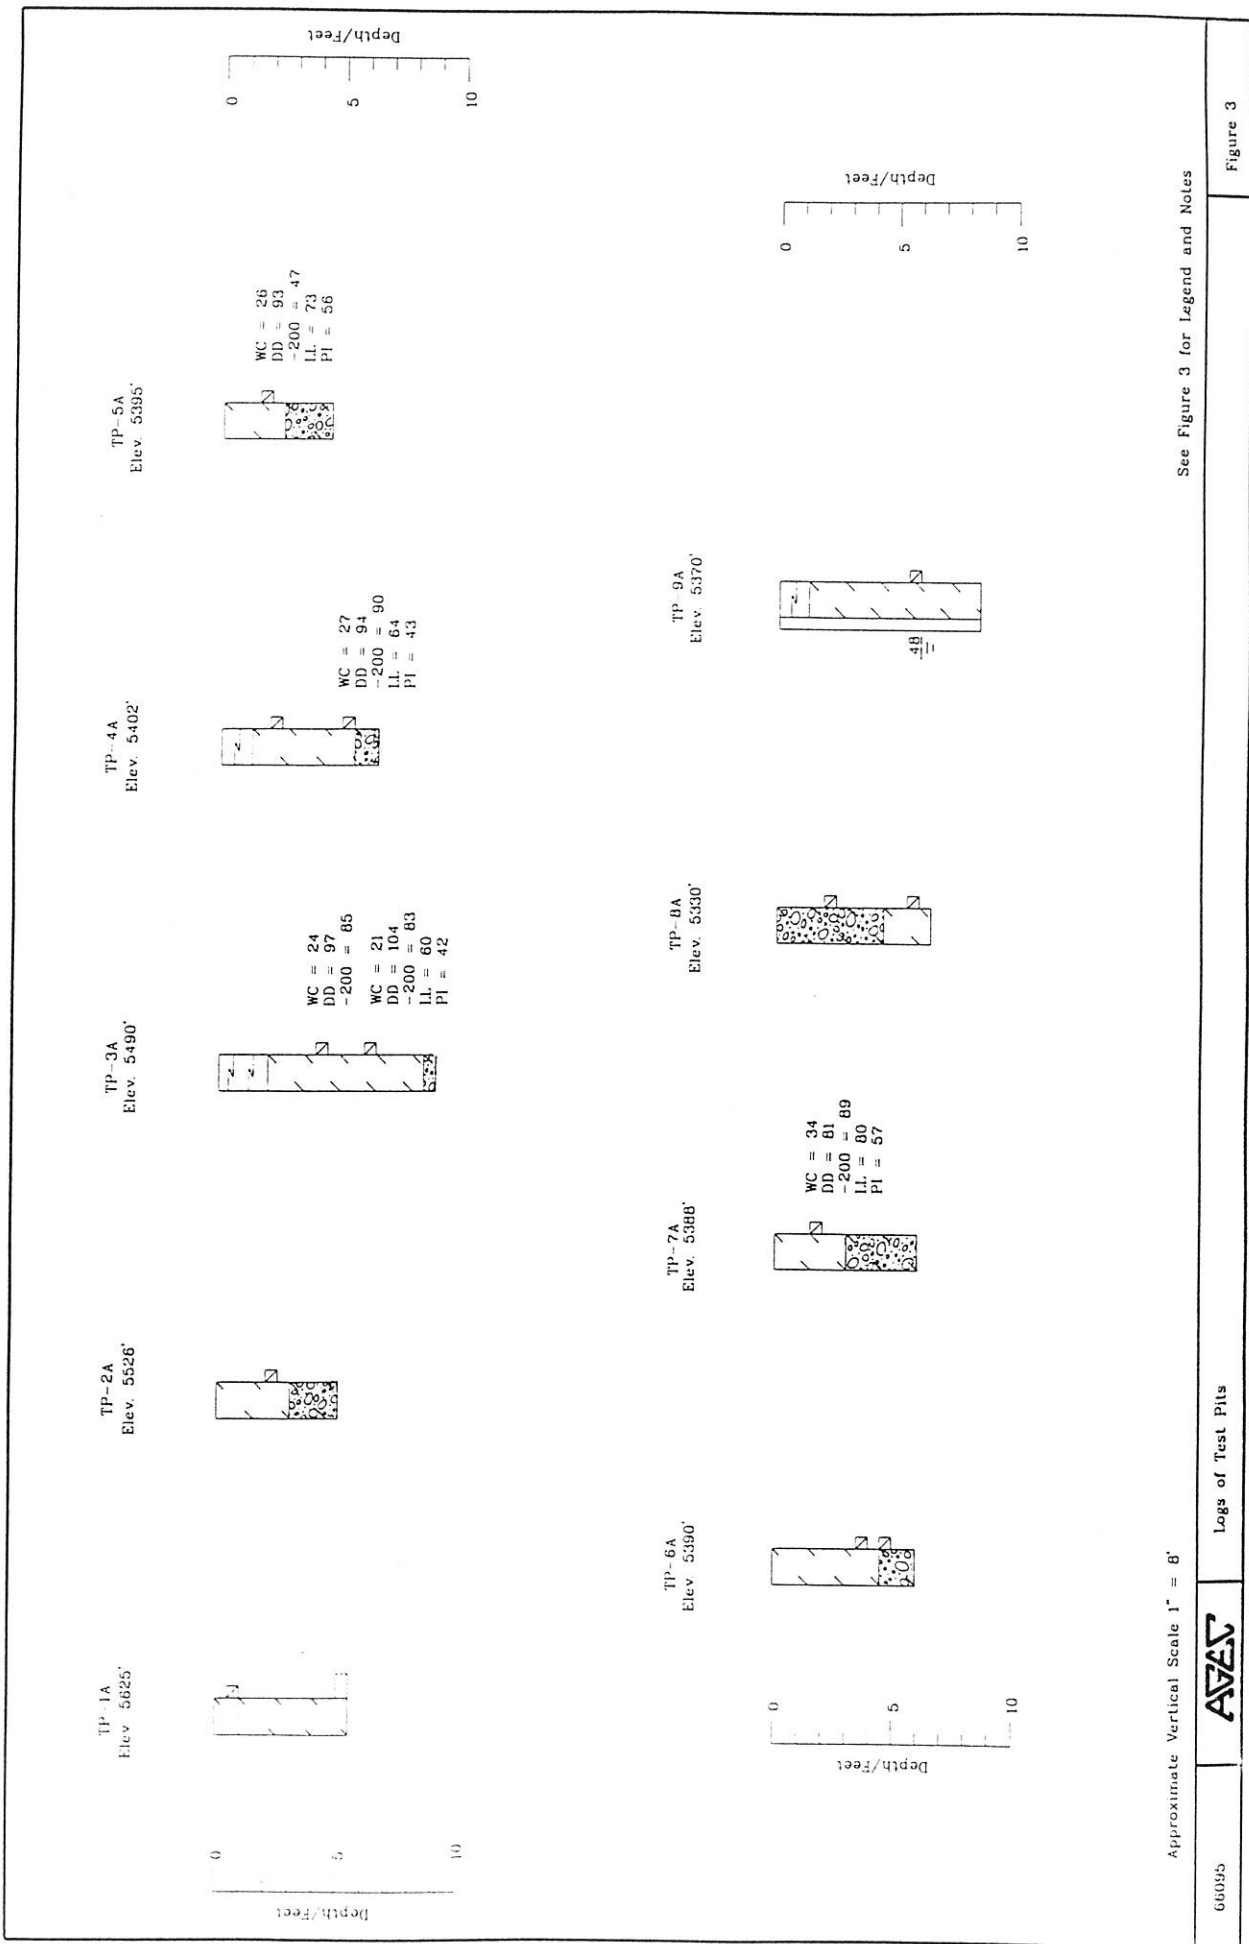
Topsol, sandy clay, moist, dark brown, roots.

Clay (CL/CH), layers of low and high plastic clay, occasional gravel and cobbles, soft to very stiff, slightly moist to wet, reddish brown to gray.

Clayey Gravel (GC), with cobbles and occasional boulders, dense, moist to very moist, brown to reddish brown to grayish brown.
